**FINAL
WRANGELL INSTITUTE
SITE ASSESSMENT
WRANGELL, ALASKA**

Alaska Department of Environmental Conservation
Spill Prevention and Response
Contracts and Grants Unit
555 Cordova Street
Anchorage, AK 99501

February, 2004

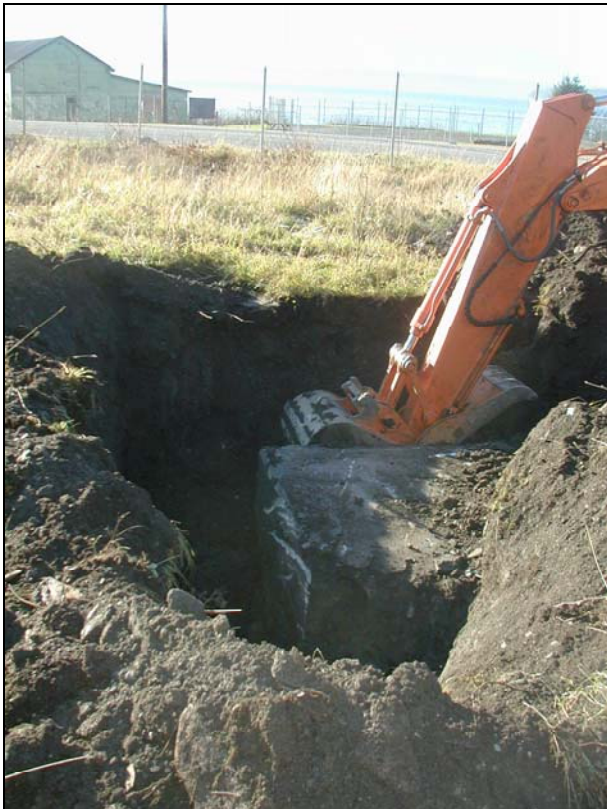
Photo 2. Concrete pad at test pit TP-B, the former location of the duplex. PetroFlag® soil samples were collected adjacent to the pad and below the pad. Results were 507 and 217 ppm, respectively.

In 2003, test pits were excavated at three locations near the former footprint of Building 205: directly below the footprint (TP-B), downgradient of the footprint (TP-C), and upgradient of the footprint (TP-E). No obvious hydrocarbon staining or odor was observed in the subsurface soil at the three test pits; however, a sheen was observed in groundwater at the bottom of TP-B, below an exposed concrete pad. Samples were collected adjacent to the pad (TP-B-3), underneath the concrete pad (TP-B-7), and downgradient of the pad (TP-C-3 and TP-C-11). Sample results are presented in Table 2. The analytical results from samples near Building 205 were below ADEC cleanup levels and the highest PetroFlag result was 517 ppm. This data suggests that there is minimal subsurface soil contamination near Building 205.

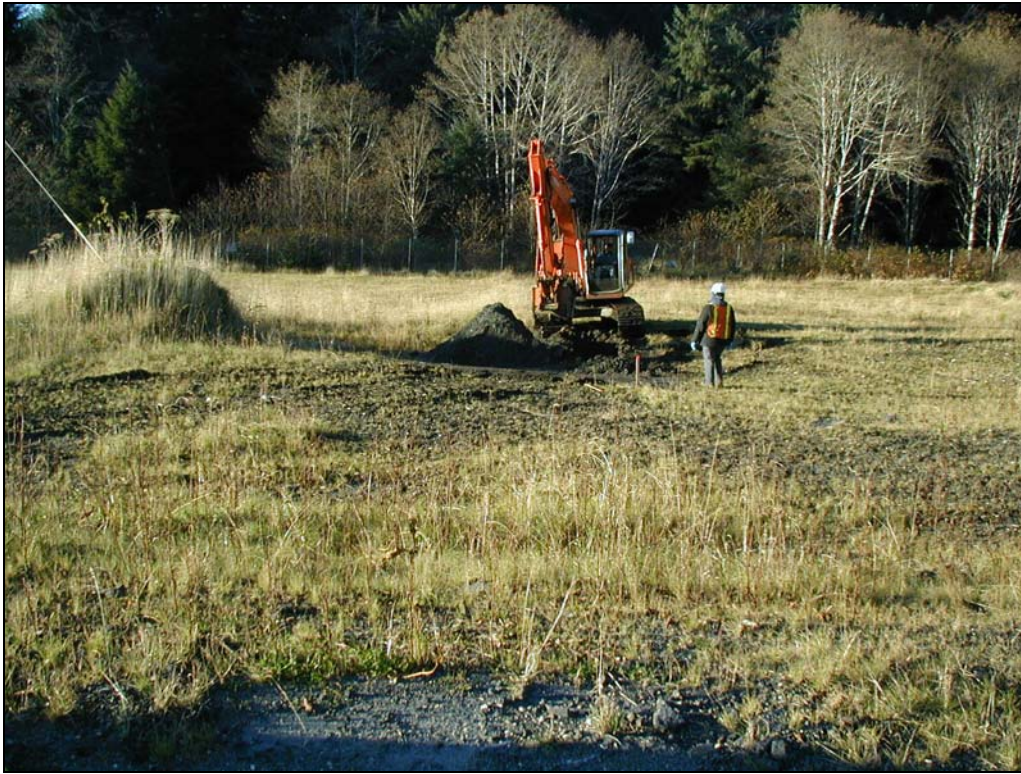
Photo 3. Looking north from the corner of Massin Avenue and Bay View Street. TP-D is being excavated; TP-H is to viewer's right and TP-G is to the left.

In 2003, thirteen samples were collected near the 3-way pipeline junction at the intersection of Bay View Street and Massin Avenue. At portions of test pits TP-D and TP-G, hydrocarbon-impacted soil extends continuously from the surface to 3 feet bgs and discontinuously from 3 feet to 7 feet bgs. Sample results are presented in Table 2. The soil is a well-graded silt-sand-gravel mixture (USCS classification GW). Maximum depth to groundwater is 2 feet bgs, and is characterized by near-artesian or near-spring conditions.

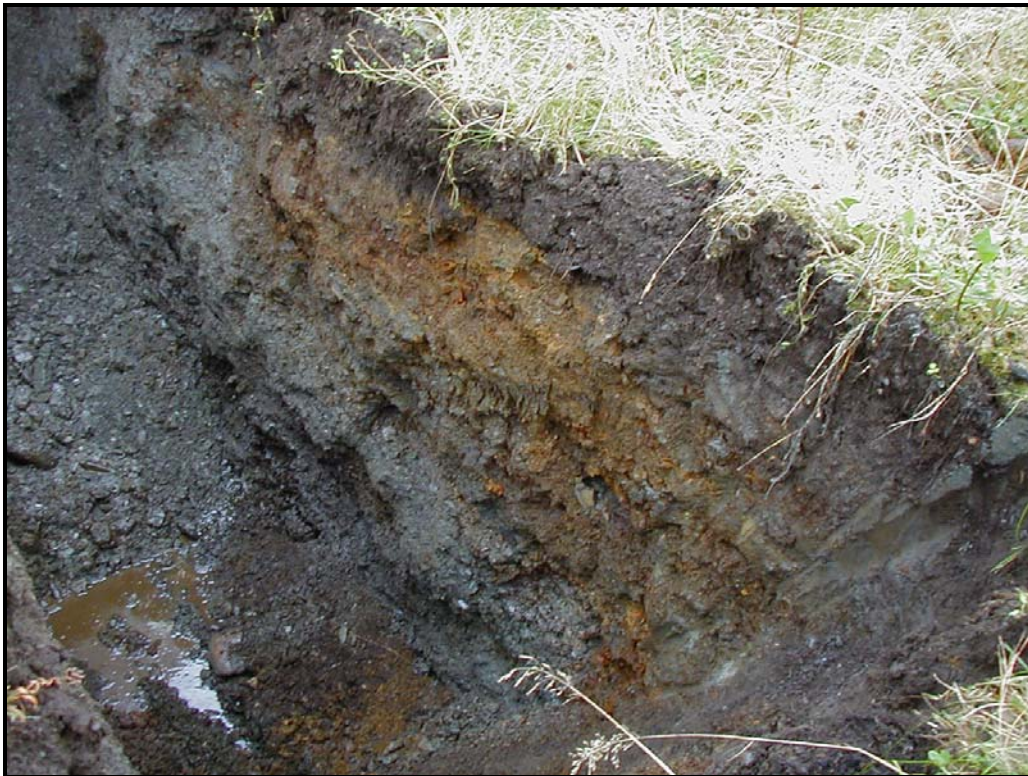
Photo 4. TP-L is located downgradient of the former Building 210. A PID screening sample of the iron-oxide stained soil at 3 feet bgs measured 6.8 ppm. At 5 feet bgs, groundwater was encountered. Hydrocarbon staining was observed in the saturated soil; a PID screening sample measured 131 ppm.

In November 2003, approximately 12 test pits were excavated near the former locations of Buildings 201 and 210 (Figure 3). Hydrocarbon-impacted subsurface soil was observed in test pits at two former UST locations, Building 210 (TP-QQ) and Building 201 (TP-II), and extending approximately 150 feet downslope to TP-QQ. The two soil samples with the highest DRO concentrations were TP-I-8 (2,800 mg/kg) and TP-P-6 (6,300 mg/kg). The maximum vertical extent of the hydrocarbon contamination was observed at location TP-I, where impacted soils extended from 2 feet to 8 feet bgs. Excavation of the test pit was halted at 8 feet bgs, where groundwater was encountered.

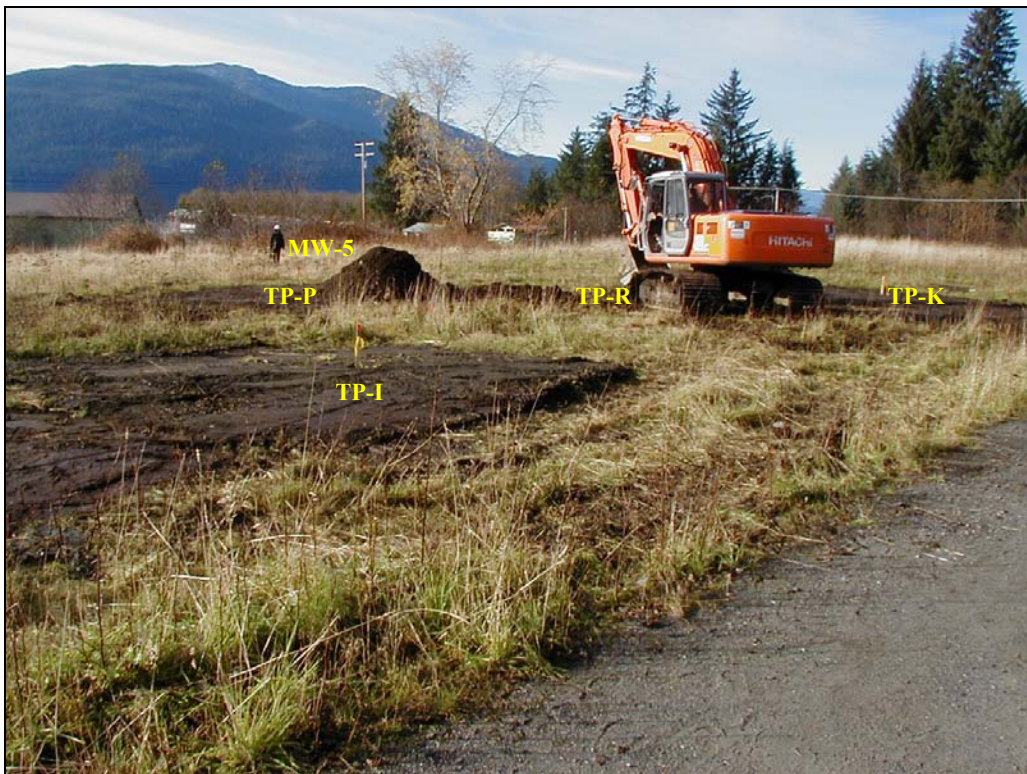
Photo 6. Opposite view from Photo 5 of Building 210 soil plume area. Taken from Bay View Street, viewing northwest. Monitoring well MW-4 was later constructed between TP-I and TP-P. Ground water samples from both MW-4 and MW-5 exceeded ADEC water cleanup levels (Table C, 18 AAC 75) and water quality criteria (18 AAC 70).

DRO was detected in groundwater samples from five monitoring wells (MW-2, MW-4, MW-5, MW-6, and MW-7); however, samples from only two wells (MW-4 and MW-5) contained concentrations exceeding the ADEC cleanup levels (Table C, 18 AAC 75) and water quality criteria (18 AAC 70). The hydrocarbon-impacted groundwater at MW-4 and MW-5 most likely reflects an area of contiguous groundwater contamination, as illustrated on Figure 5. The plume may extend approximately 270 feet down slope to the northwest, where hydrocarbon-impacted, water-saturated soil was observed at 10 feet bgs. Soil sampled from that location (TP-A-9 and TP-A-10) contained values at (or above) the ADEC Method 2 DRO cleanup level.

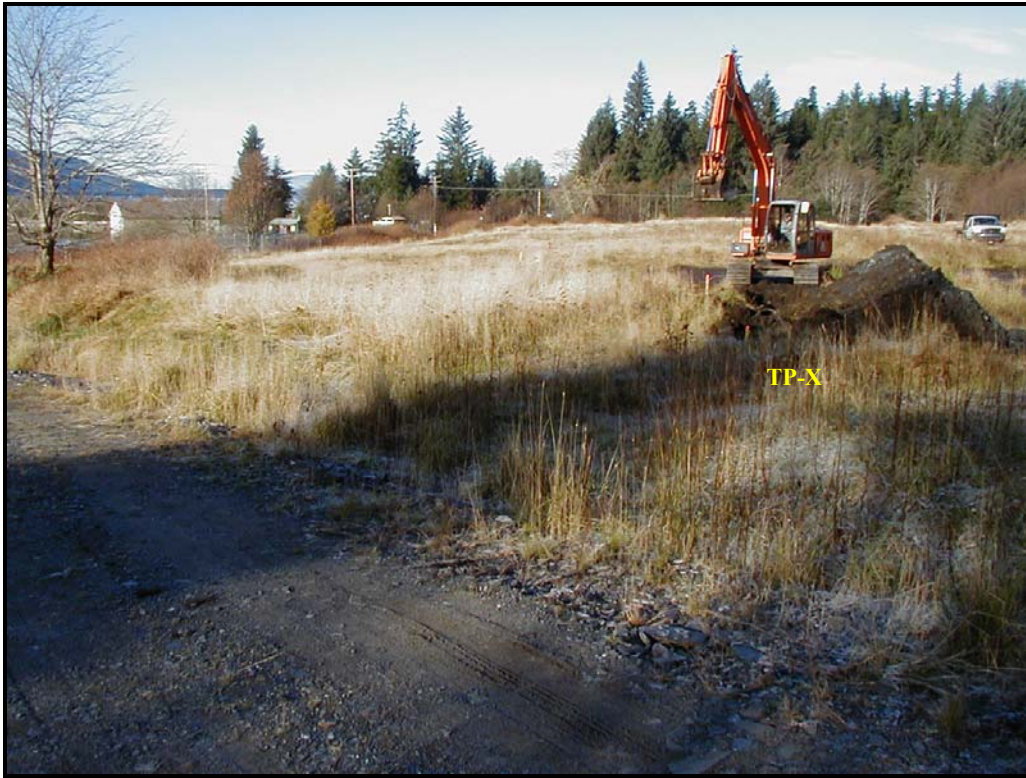
Photo 7. Viewing northwest, with Institute Drive in the foreground. Sample TP-X-3.5 contained DRO at a concentration of 1,200 mg/kg.

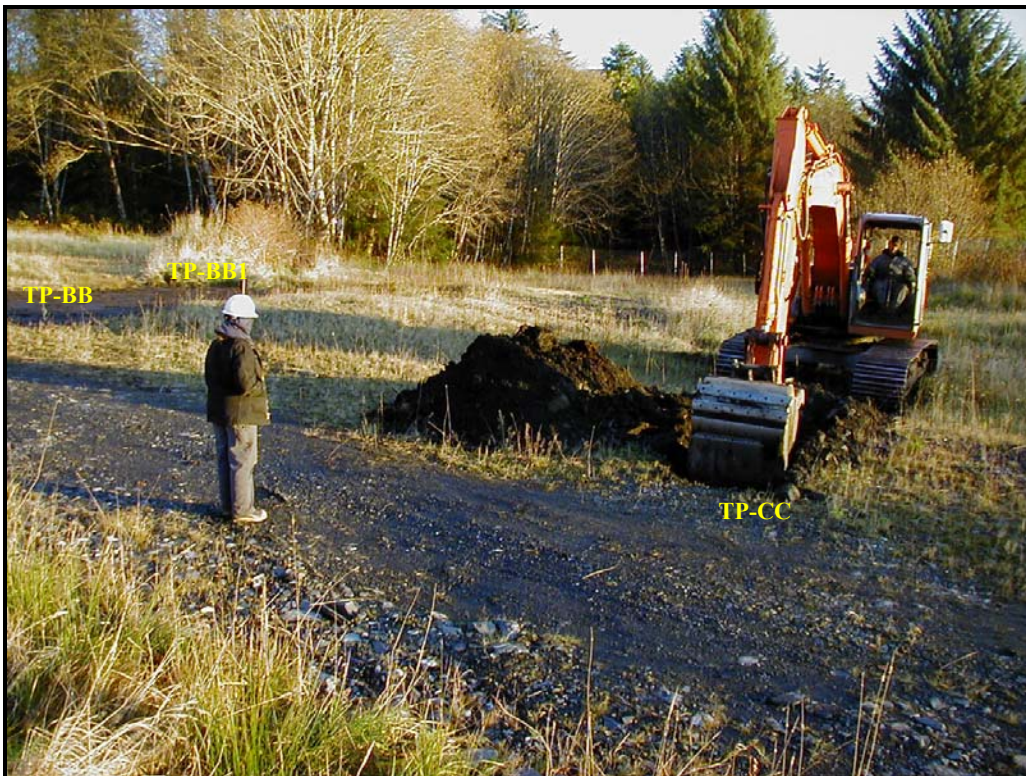
Photo 8. Viewing southeast, with Institute Drive in the foreground. Test pits TP-BB, TP-BB1, and TP-CC delineated the soil plume in the southern direction.

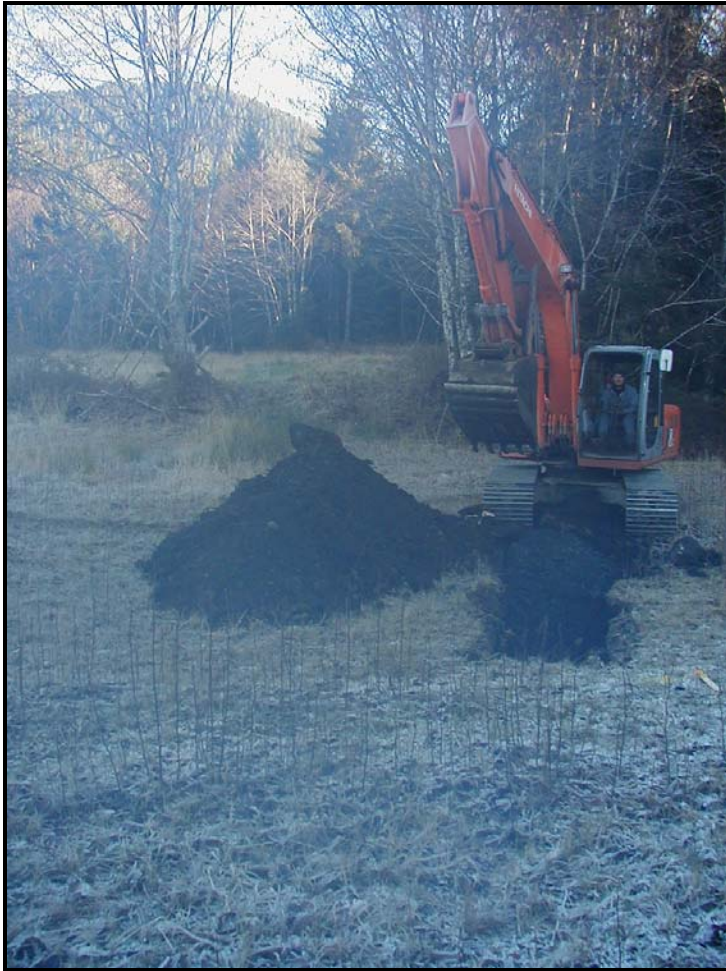
Photo 9. TP-DD, located at Building 209 (South Staff Residence), contained hydrocarbon concentrations below ADEC Method 2 cleanup levels. The former location of the two primary 20,000-gallon ASTs is barely visible in the background, almost visible.

In 1999, RA/TELLUS removed the UST and approximately 42 cubic yards of contaminated soil at the former location of Building 209, the South Staff Residence (RA/TELLUS, 1999). In 2001, hydrocarbon-impacted soil was observed near the center of the building footprint. An additional 60 cubic yards was removed from the area. Two confirmation samples were below ADEC Method 2 cleanup levels (CDI, 2003).

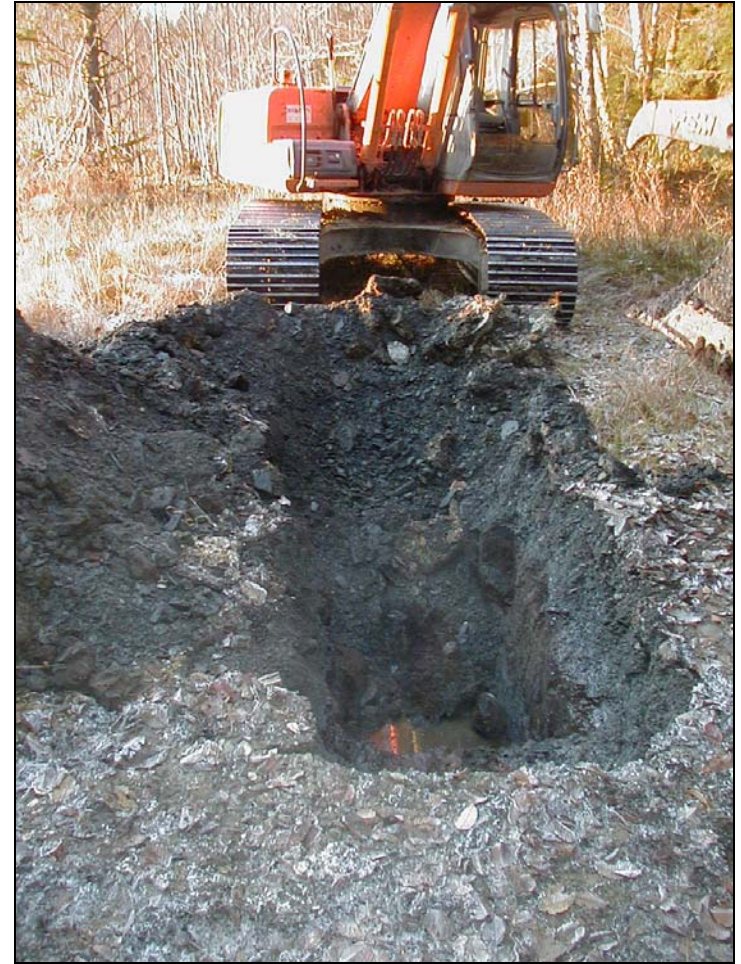
Photo 10. TP-HH is located at two primary 20,000-gallon ASTs. A sample collected from the stained zone at 2 feet bgs contained 5,000 mg/kg DRO.

The former location of the two primary 20,000-gallon ASTs is the southeastern corner of the Institute. The area is elevated approximately 6 feet above the natural grade. Hydrocarbon-impacted soil was observed on the surface and down to 3 feet bgs in the saturated silt-sand-gravel subsurface soil. Three analytical samples (TP-HH-2, TP-PP-1, and TP-DUP-4) averaged 4,666 mg/kg (Table 2).

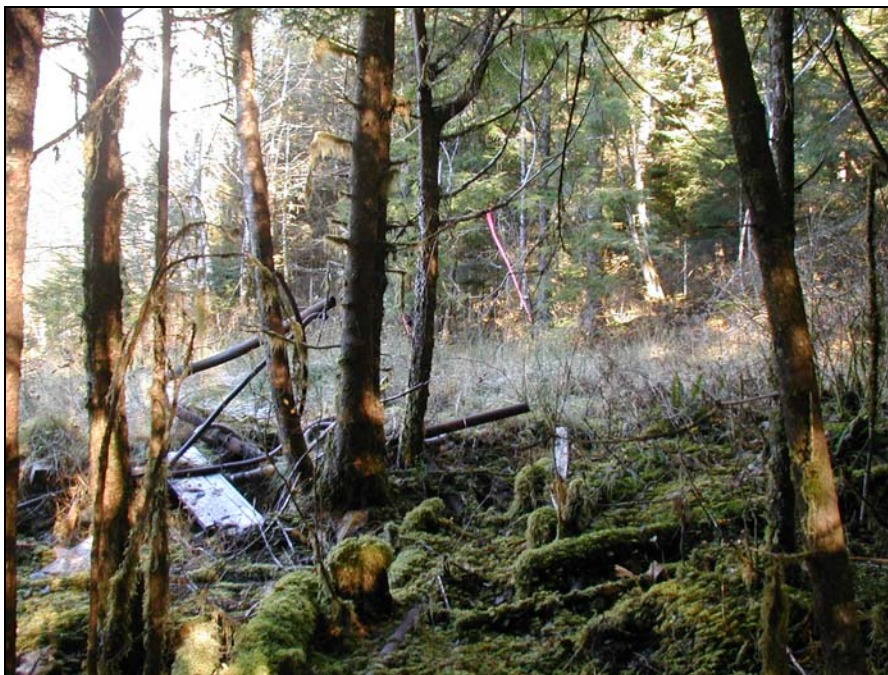
Photo 11. Looking north, towards the former location of the two 20,000-gallon ASTs as viewed from sample location PJ-1 (on the 3-inch supply pipeline).

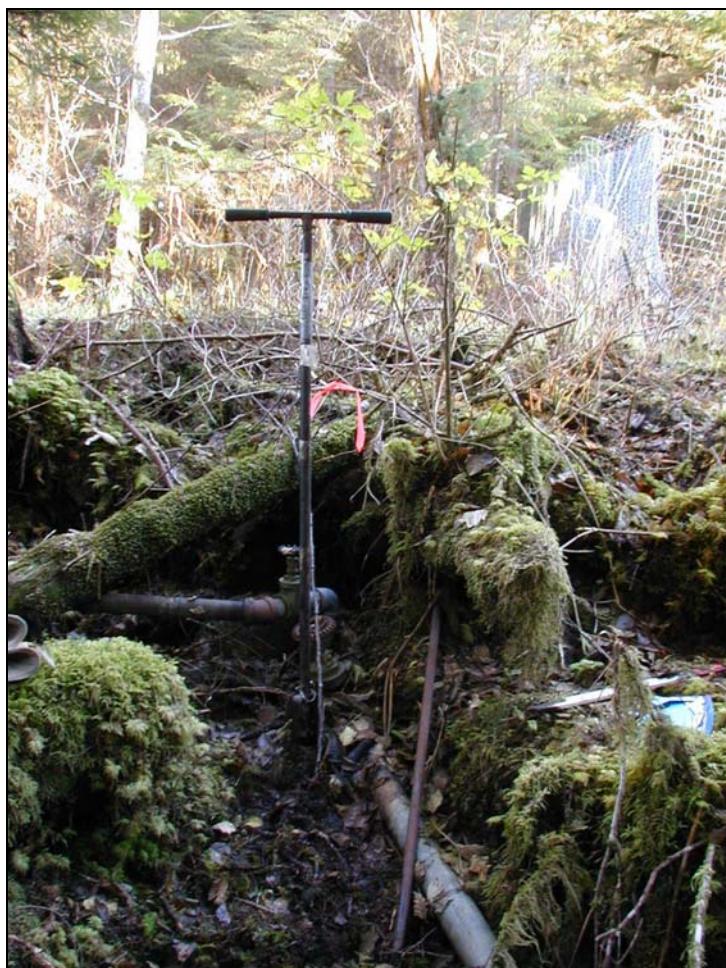
Photo 12. Three-inch supply pipeline at sample location PJ-4. The hand auger is placed at T-junction to 2-inch supply pipeline.

The 3-inch diameter supply pipeline is located along the southern boundary of the property. The pipeline was observed on the ground surface and down to a depth of 6 inches. Approximately one-third of the pipeline is within the property; the remaining portion is located outside the fence and property boundary. The pipeline is comprised of 21-foot-long threaded segments of 3-inch-diameter steel pipe.

The soil underlying the supply pipeline is predominantly silt and organic material (tundra mat). Sand and gravel underlies the silt at approximately 2 feet bgs. Hydrocarbon-impacted subsurface soil was observed at three areas along the supply pipeline (PJ-4 through PJ-6, PJ-11, and PJ-15 through PJ-17). Analytical samples collected from each of the areas had concentrations above ADEC cleanup levels (samples PJ-4-1.5, PJ-6-0.5, PJ-11-1.5, and PJ-15-0.5). The DRO concentrations exceeding the ADEC cleanup level in this area ranged from 1,400 mg/kg to 150,000 mg/kg.

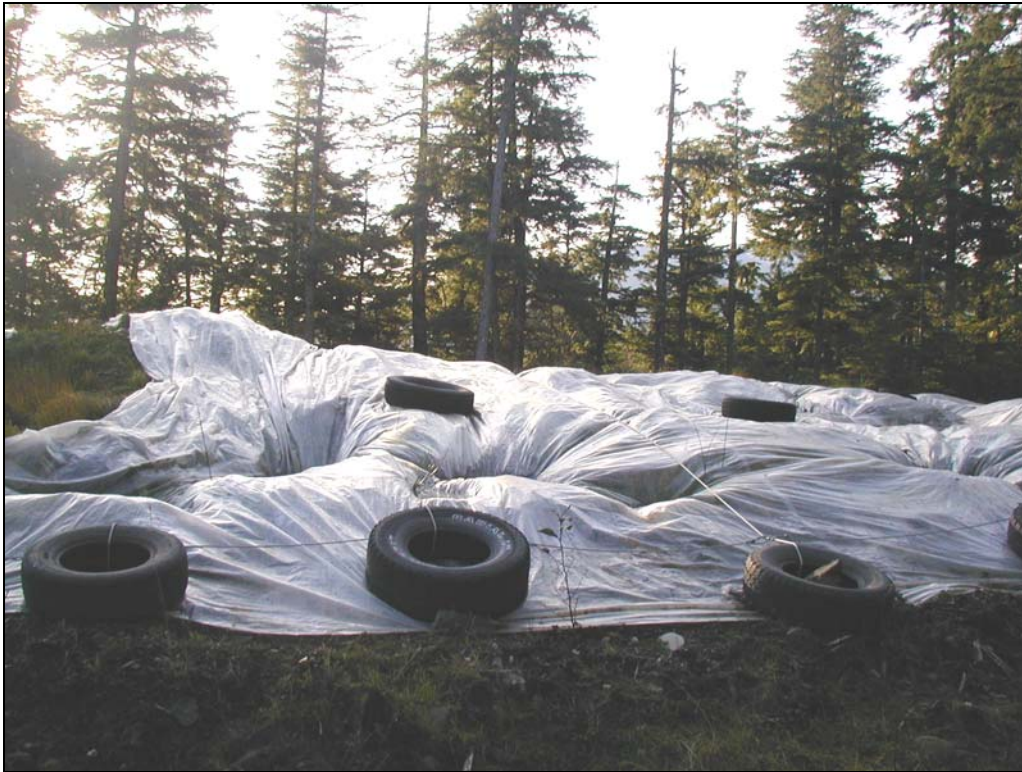
Photo 13. CDI stockpile, located approximately $\frac{1}{4}$ mile north of the Institute.

In November 2003, four stockpile samples (and one duplicate) were collected from the soil in the CDI stockpile believed to have been excavated from areas other than Building 205. The sample results are presented in Table 5. DRO concentrations ranged from 1,100 mg/kg to 1,200 mg/kg. No BTEX concentrations exceeded ADEC Method 2 cleanup levels. The stockpile is in generally good condition, although the top liner has partially separated and exposed the underlying soil (Appendix B, Photo 13).
